CASE STUDY

400 feet beneath the Houston Zoo Bluelight LED CIPP tames beastly I&I

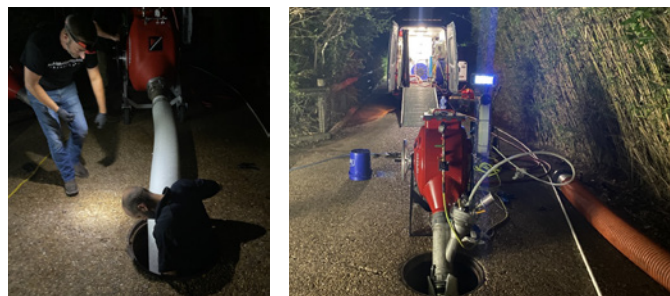
Each 200-foot manhole-to-manhole liner inversion is followed by a transparent calibration tube, which carries the LED head to the other end.

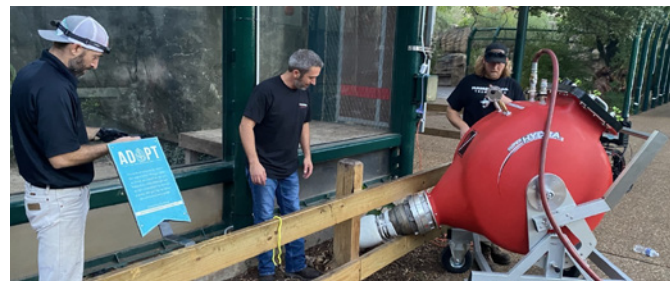
The LED CIPP pipe rehab operations take place at night and require no construction work. The trenchless technique has zero impact on the zoo's routine activities or its daily patronage.
